Debris/Ice/TPS Assessment and Integrated Photographic Analysis of Shuttle mission STS-102

Technical Memorandum – 2001 – 210257

May 2001

**DEBRIS/ICE/TPS ASSESSMENT
AND
INTEGRATED PHOTOGRAPHIC ANALYSIS
OF
SHUTTLE MISSION STS-102**

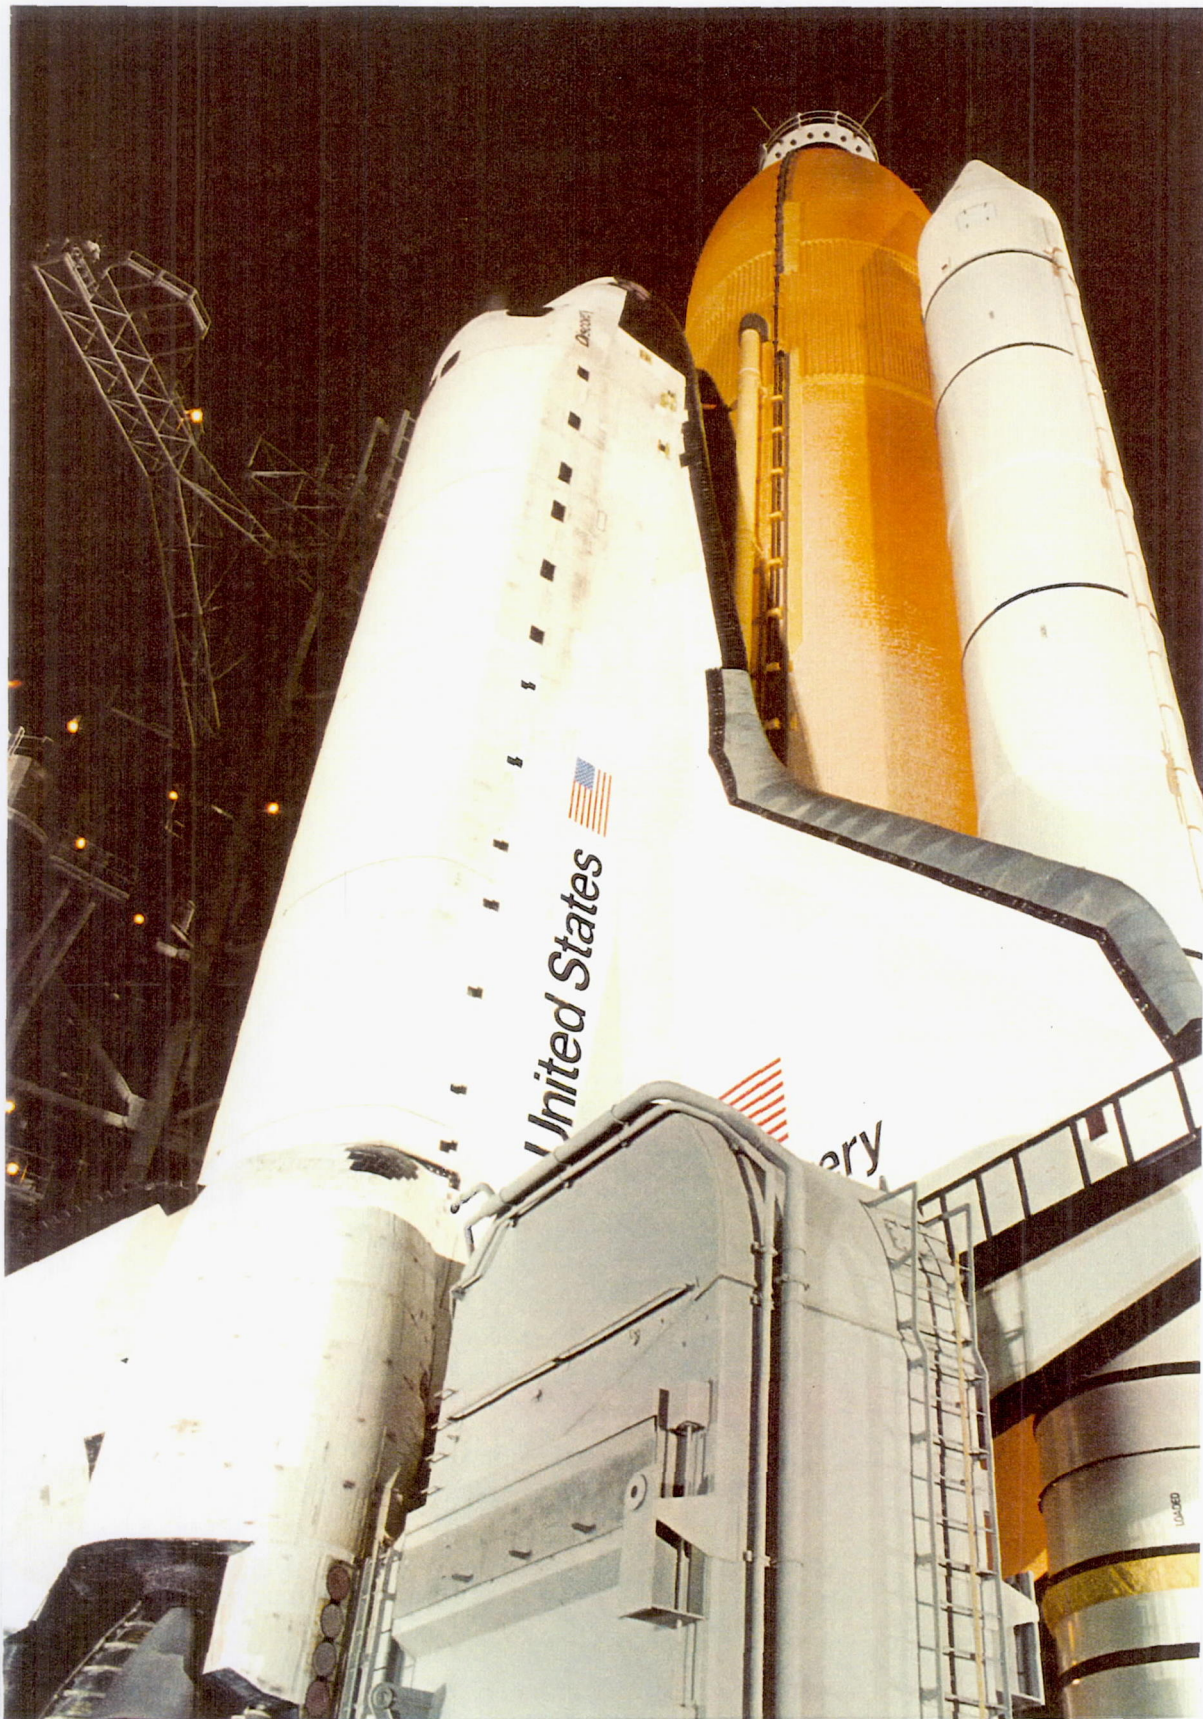
Photo 2: Frost on LH2 Tank

Some patches of frost were observed on the LH2 tank acreage, particularly the +Y-Z and the +Y+Z quadrants. Surface temperatures ranged from 32 to 40 degrees Fahrenheit. There were no acreage TPS anomalies. Two small frost spots were observed on the aft dome manhole cover closeout.

Some patches of frost had formed in the +Y+Z quadrant. Surface temperature ranged from 32 to 40 degrees Fahrenheit. Image taken during the FIT walkdown.

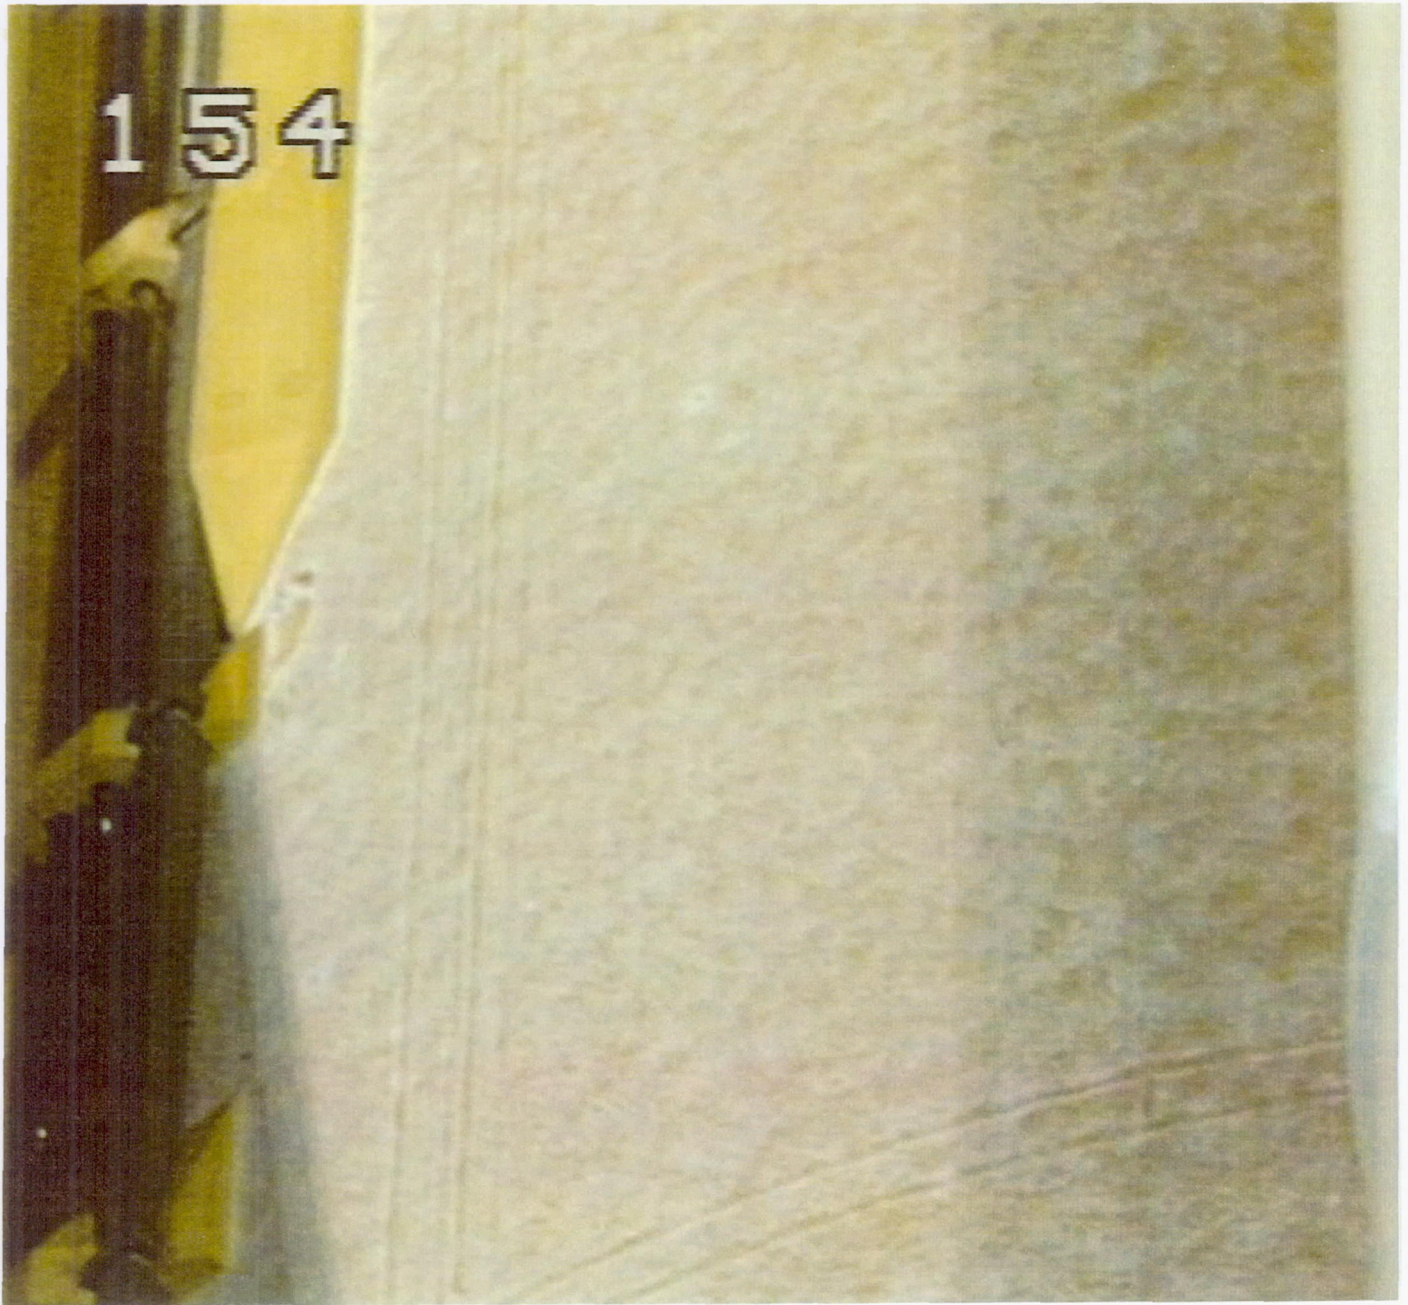
Photo 3: LH2 Tank Acreage

During OTV surveillance, after completion of the FIT walkdown, an increase in frost formation was observed on the LH2 tank acreage. This image was captured by OTV camera 154 during the T-20 minutes built-in-hold.

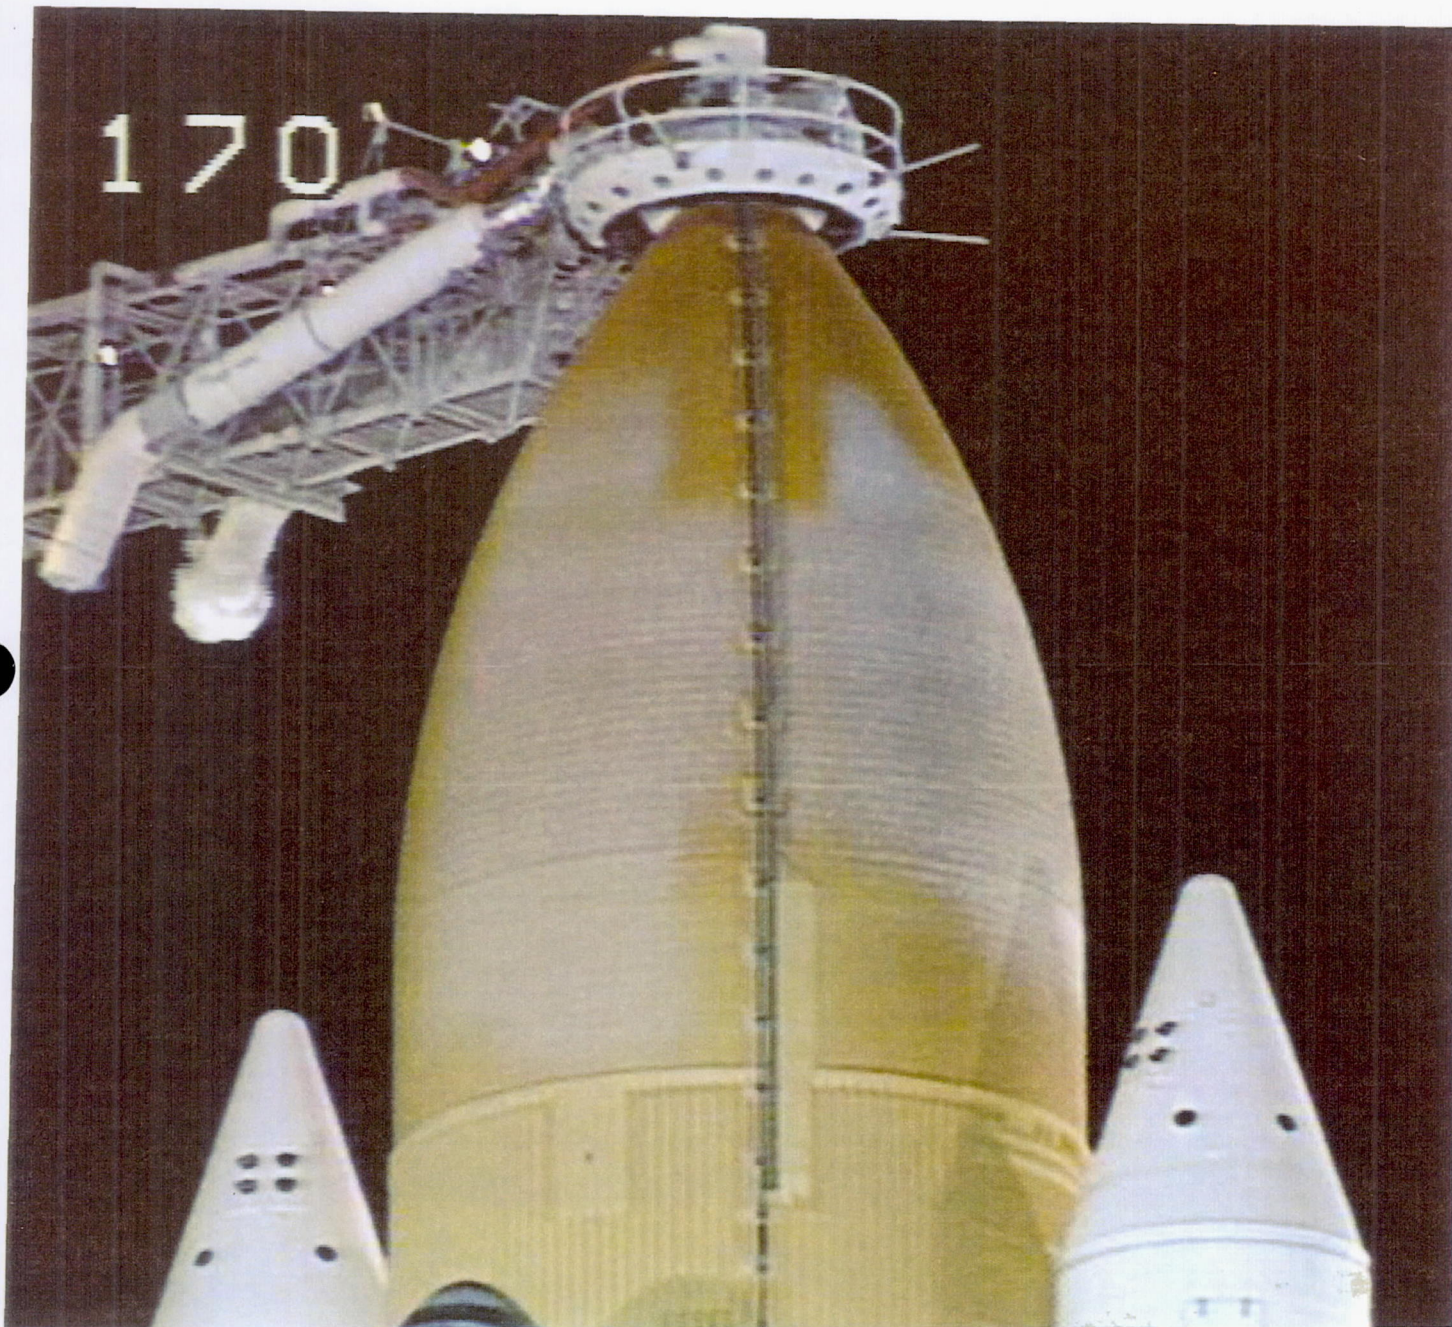
Photo 4: ET LO2 Tank Forward

Frost was present on the LO2 tank acreage. Surface temperature ranged from 32 to 41 degrees Fahrenheit. There were no acreage TPS anomalies. This image was captured by OTV camera 170 during the T-20 minutes built-in-hold.

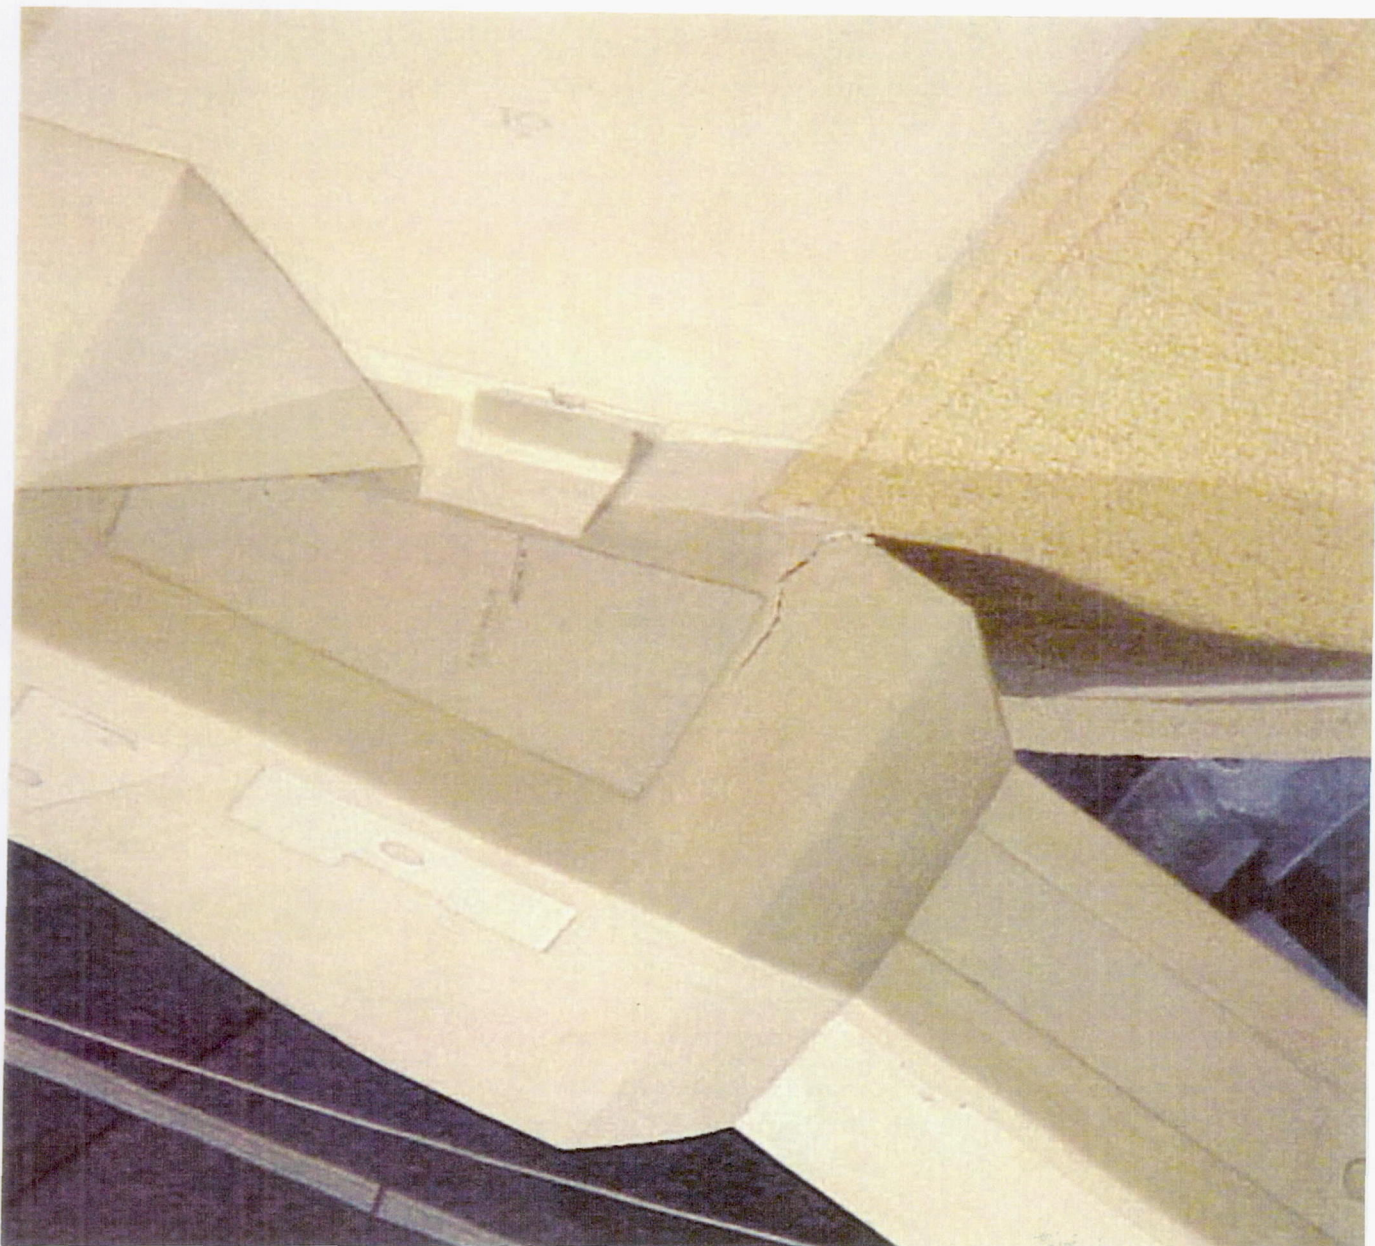
Photo 5: Cracks in -Y Vertical Strut

A 8-inches in length and .25 inches wide stress relief crack was observed in the -Y vertical strut TPS with no offset. This condition has been observed on previous vehicles and found acceptable for flight per the NSTS-08303 criteria.

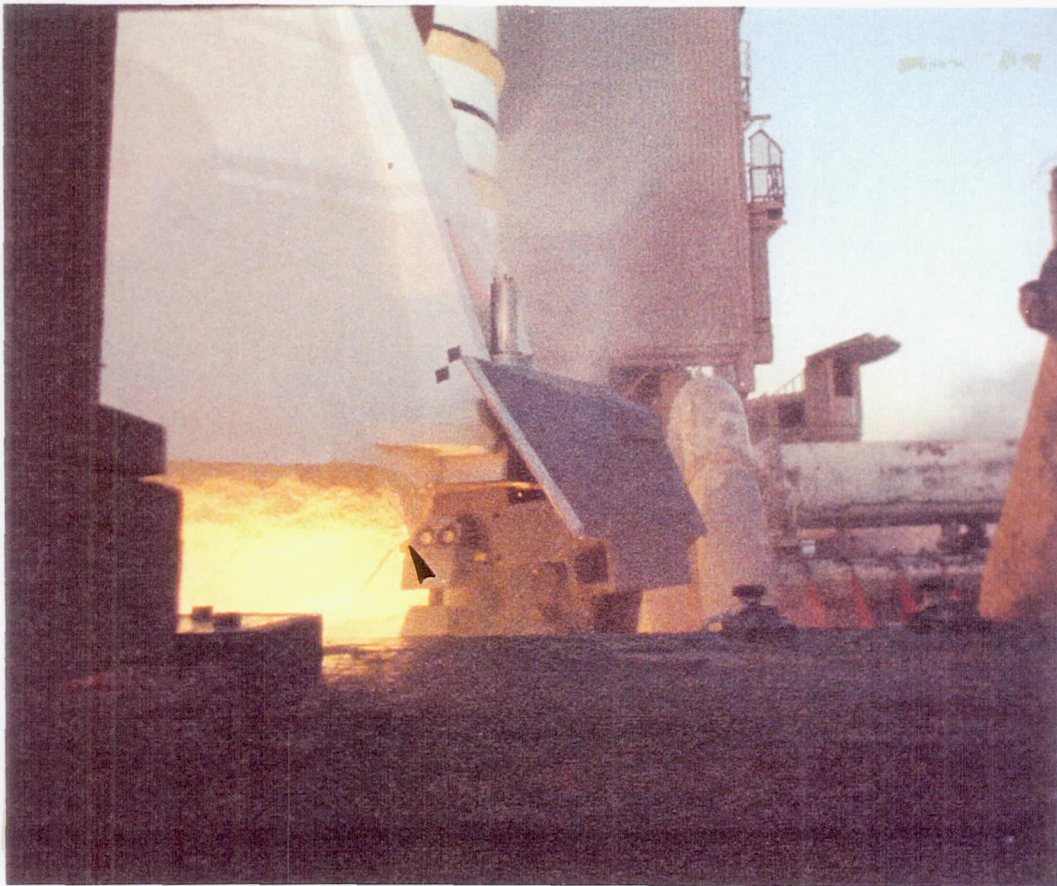
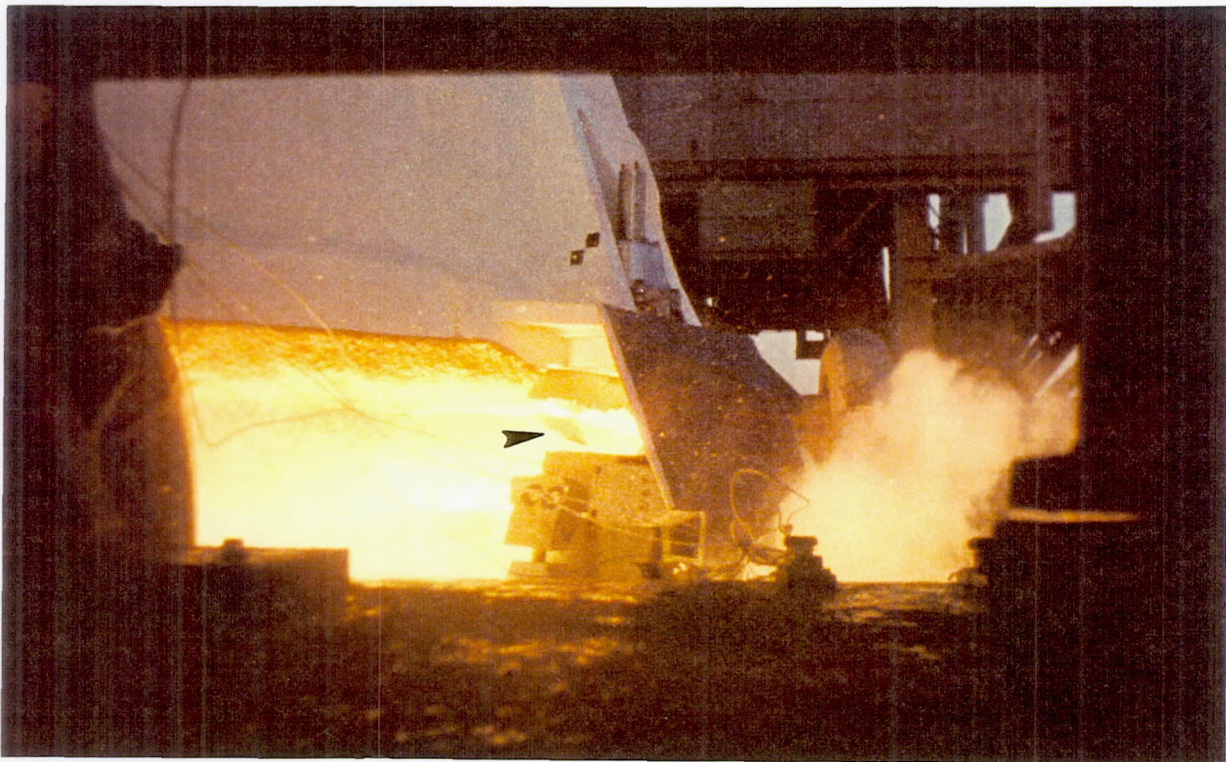
Photo 8: SRB aft skirt instafoam material broke off during lift off

Piece of SRB aft skirt instafoam material broke off during lift off due to contact with shoe retainer bracket on hold down post #4 (E-7) (11:42:09.438 UTC). Another piece of instafoam broke off due to contact with hold down post #7 shoe (E-11) (11:42:09.595 UTC)..

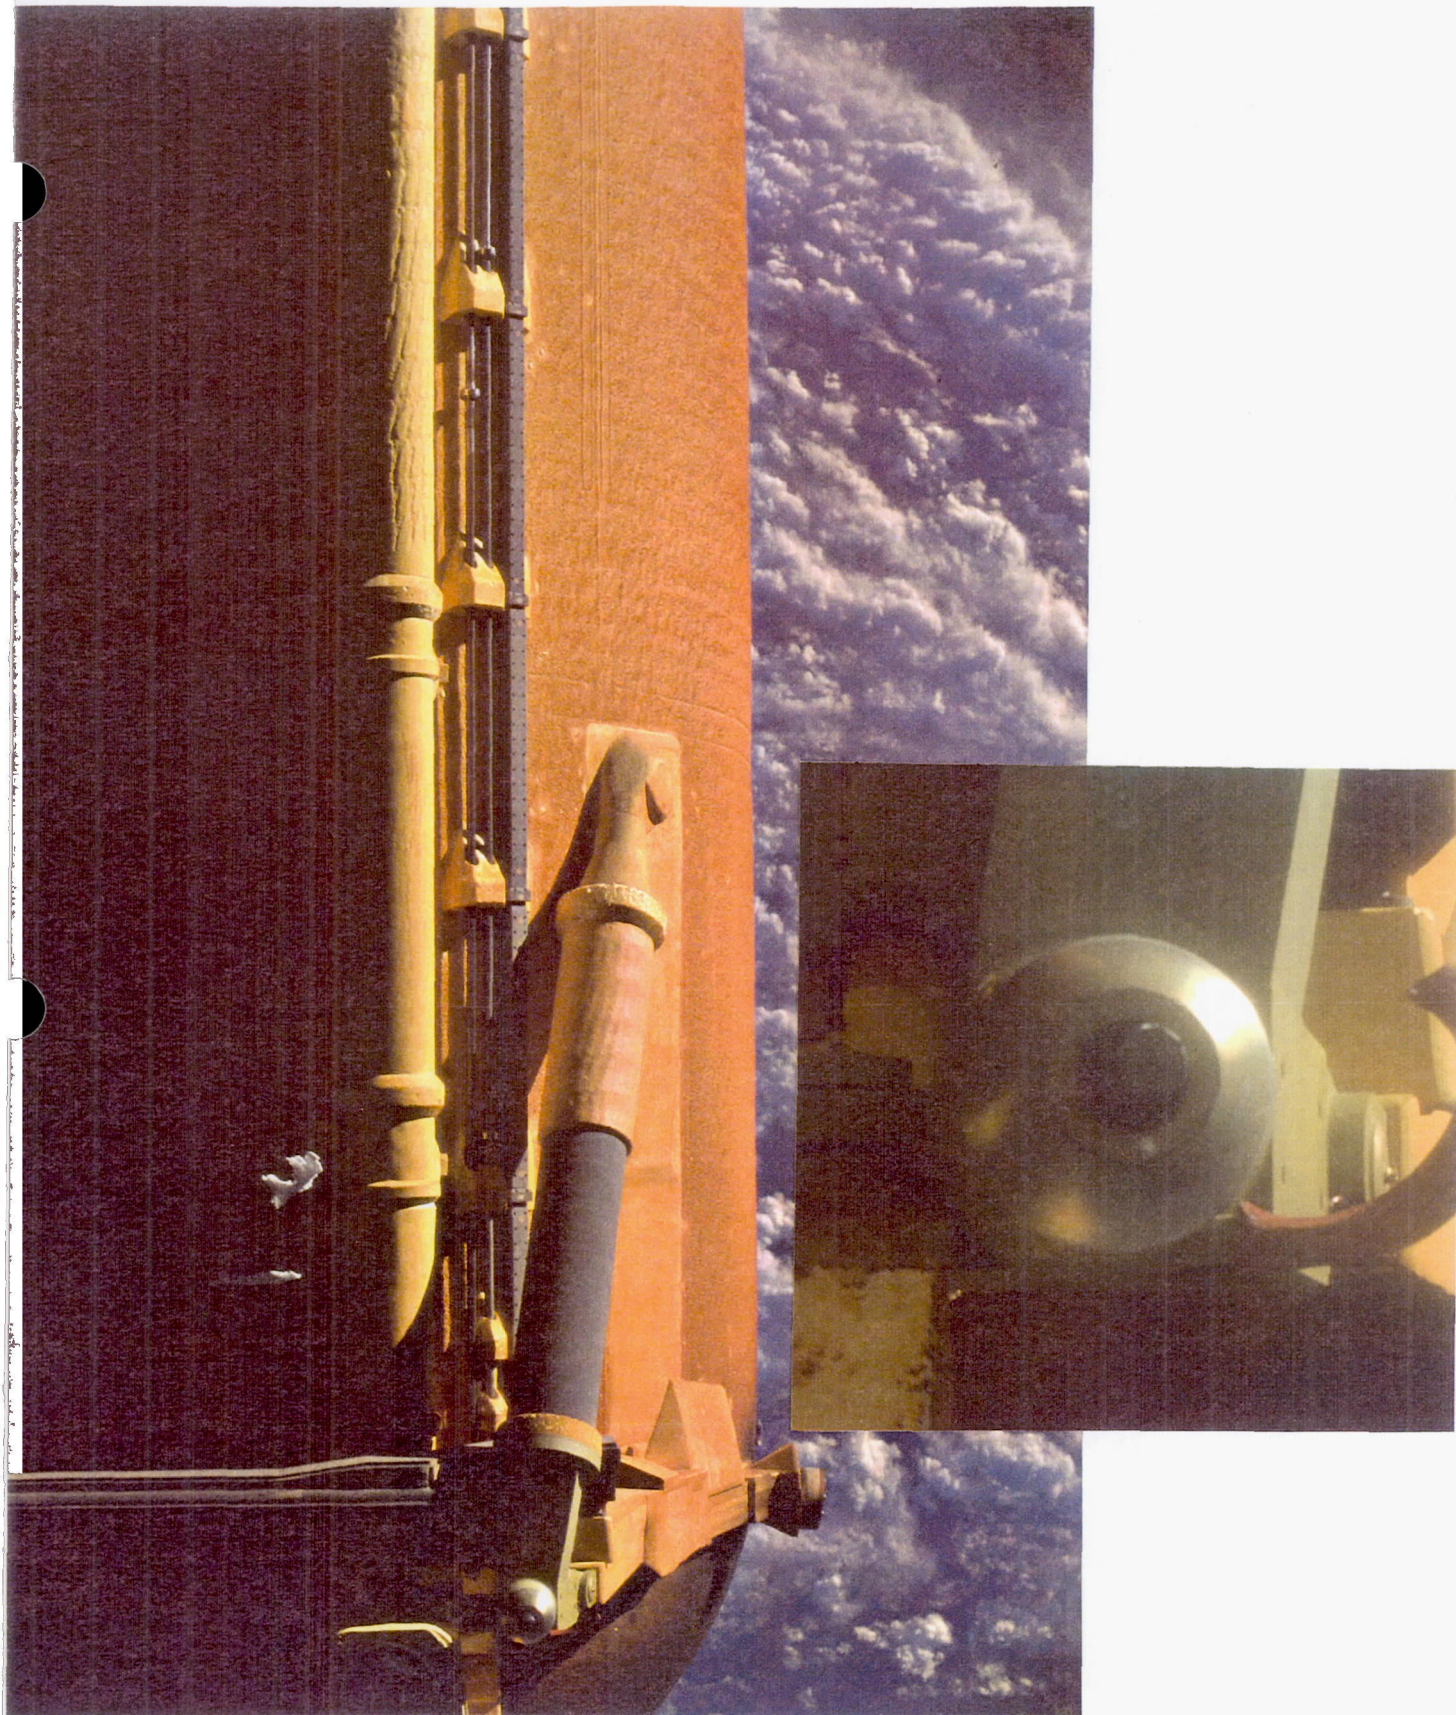
Photo 12: View of the External Tank after sep

No anomalous condition was noticed. EO-3 (LO2 side) separation bolt protrusion was observed.

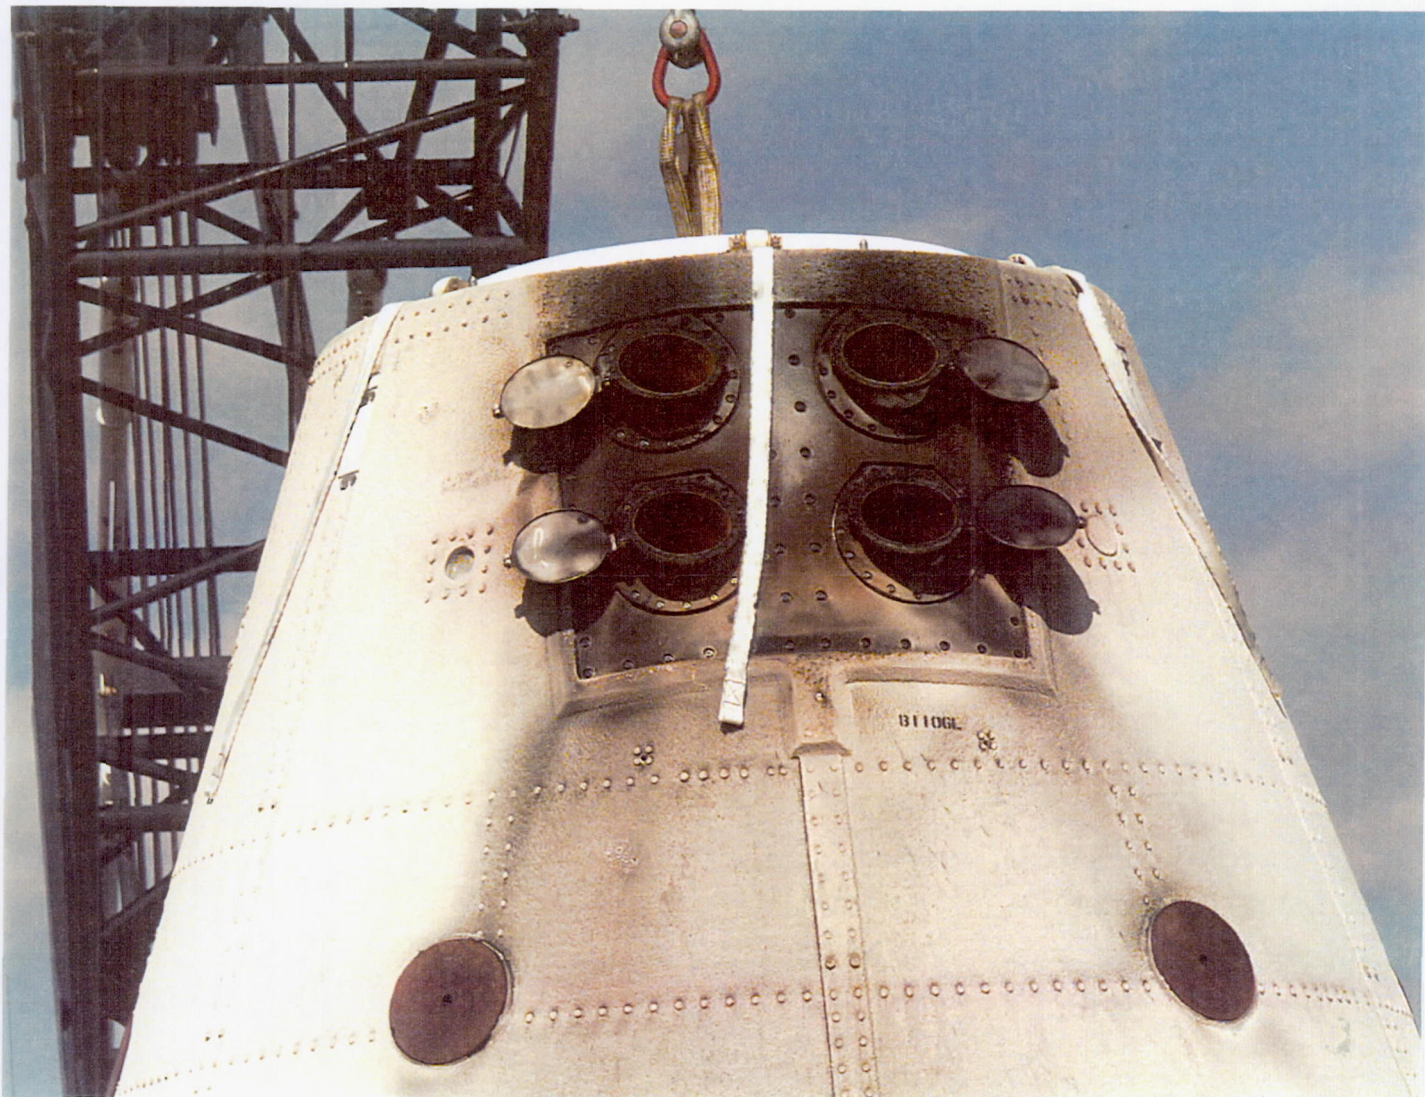
Photo 12: Frustum Post Flight Condition

The frustums exhibited no debonds/unbonds or missing TPS.
All eight BSM aero heat shield covers had locked in the typical opened position.

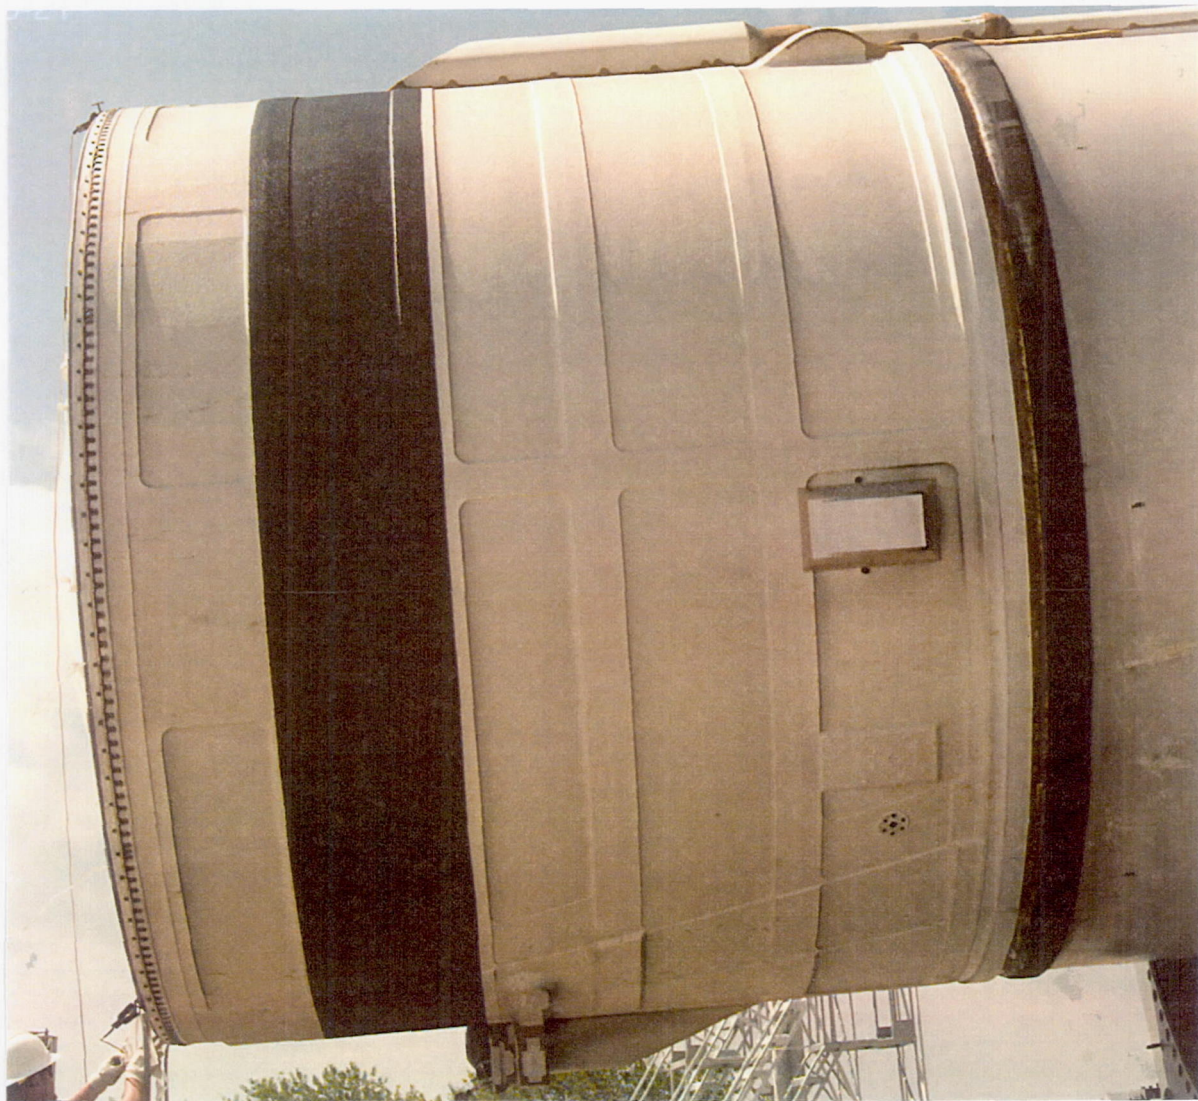
Photo 13: Forward Skirt Post Flight Condition
The forward skirts exhibited no debonds or missing TPS.

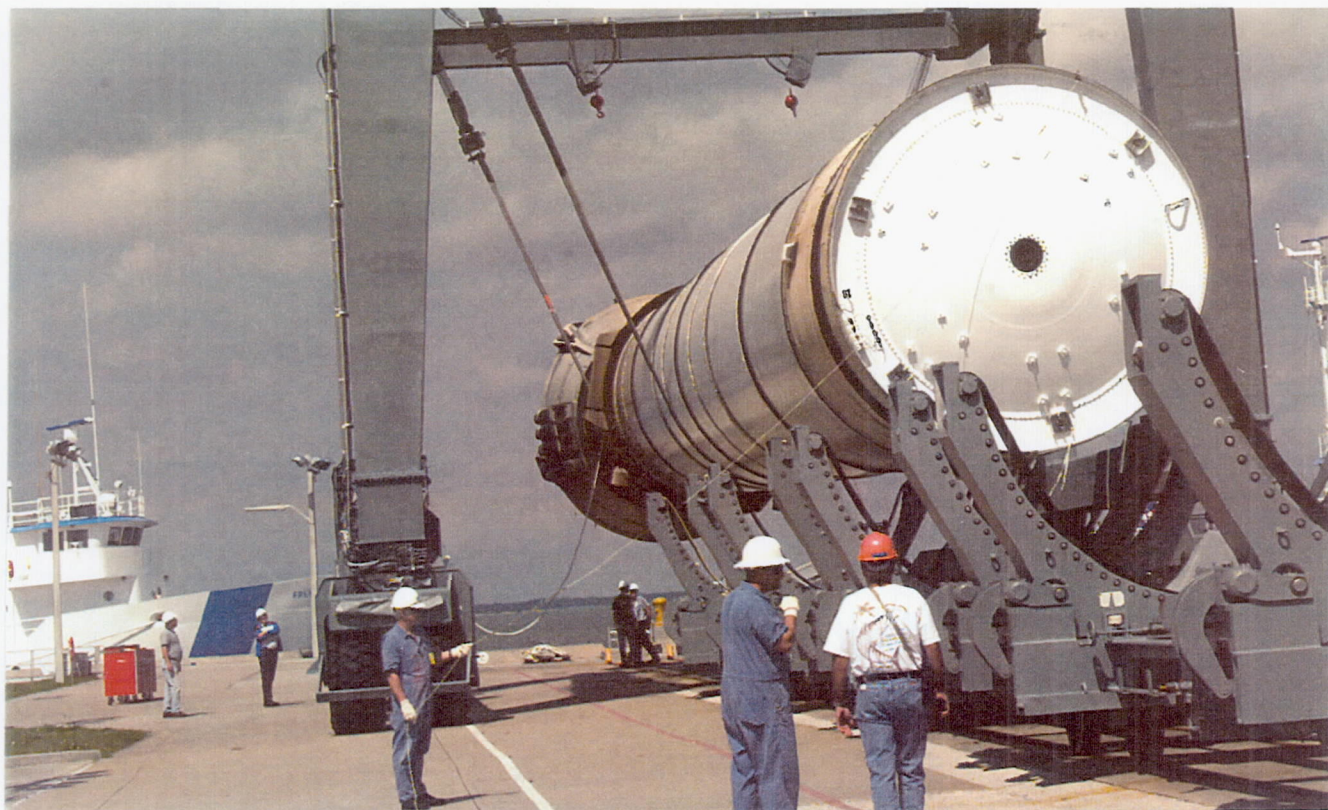
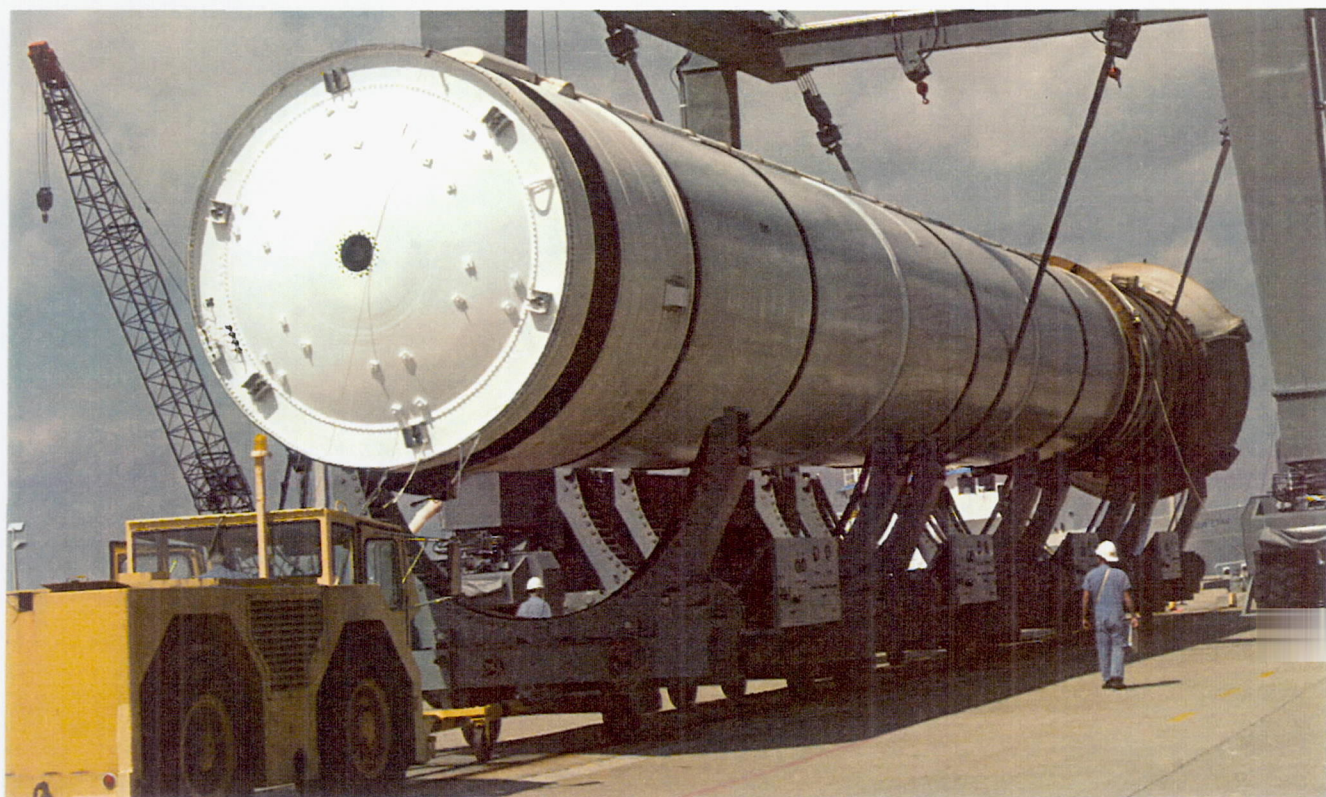
Photo 14: SRB Post Flight Condition
Both SRB's were found in good condition regarding debris assessment

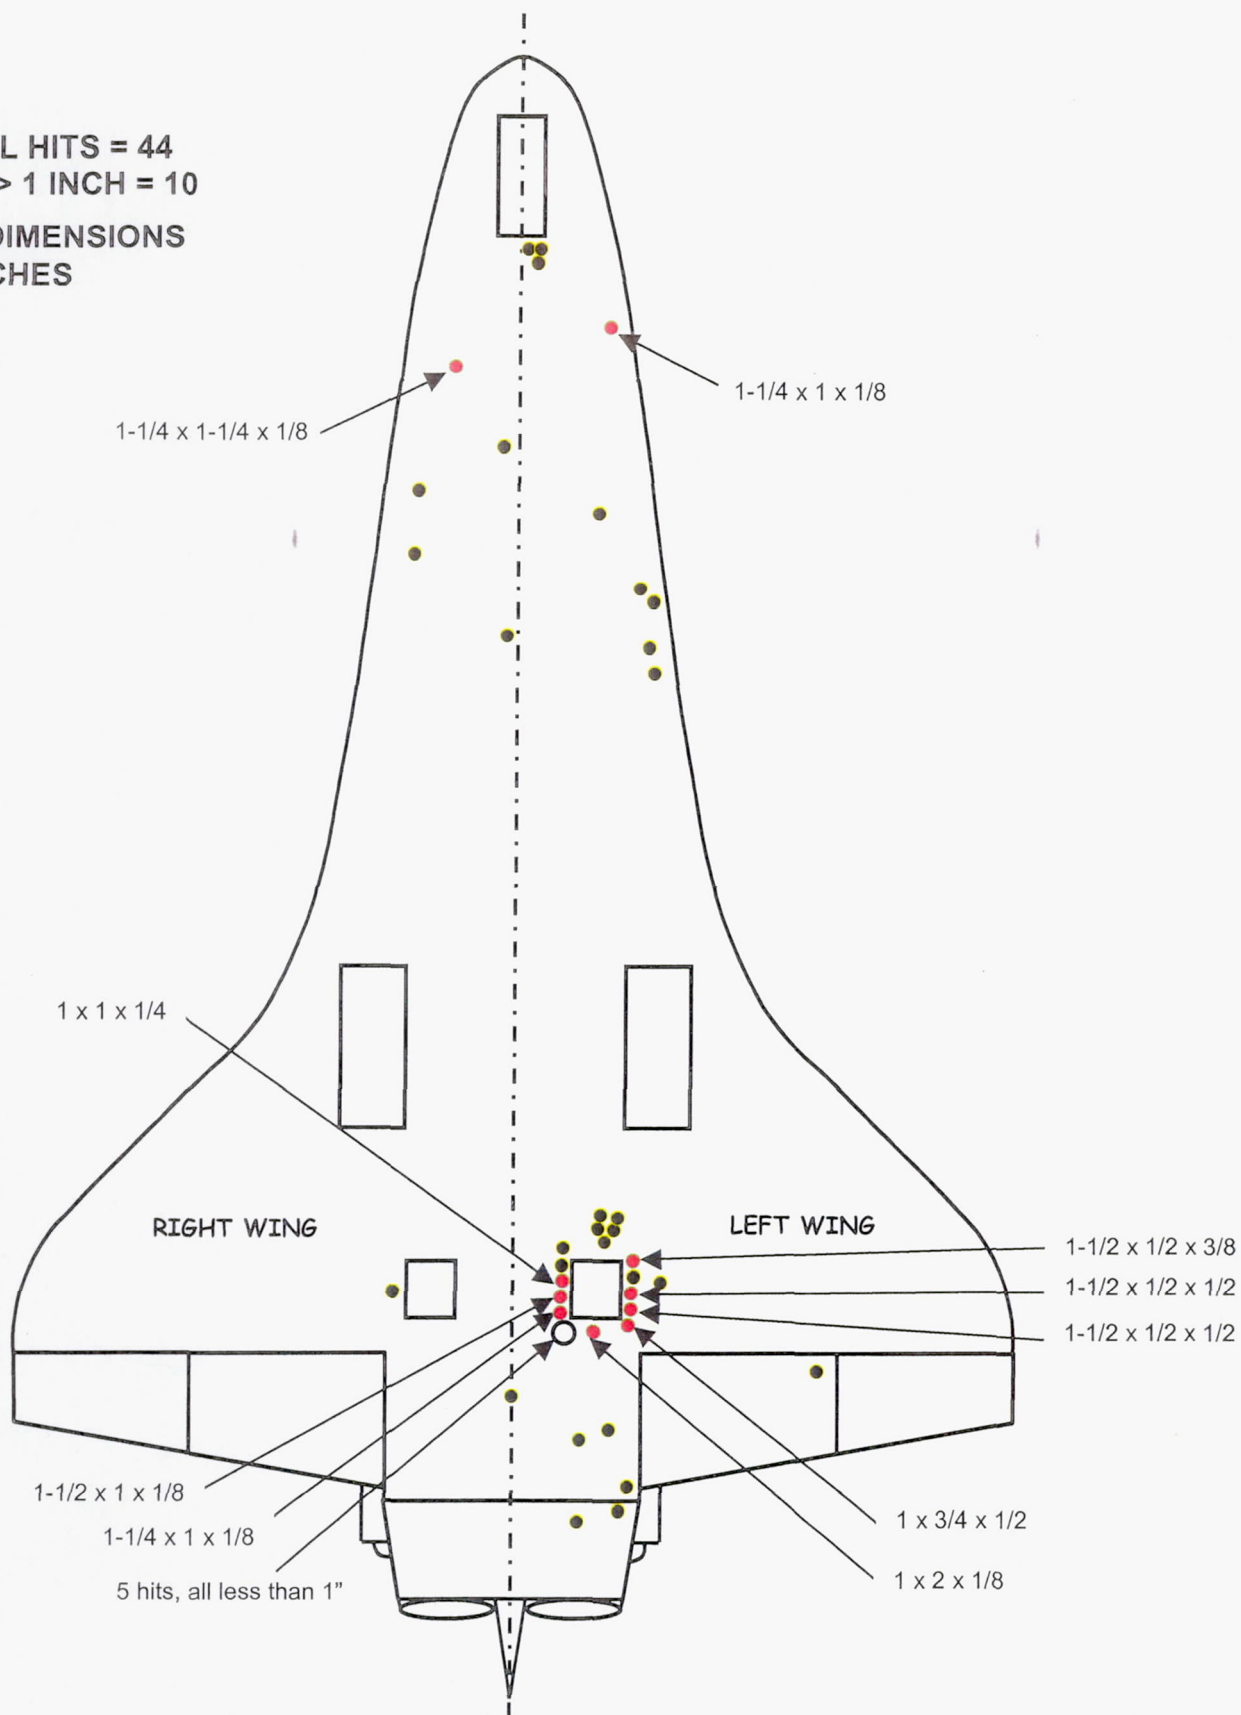
Figure 1: Orbiter Lower Surface Debris Damage Map

TOTAL HITS = 44
 HITS > 1 INCH = 10
 ALL DIMENSIONS
 IN INCHES

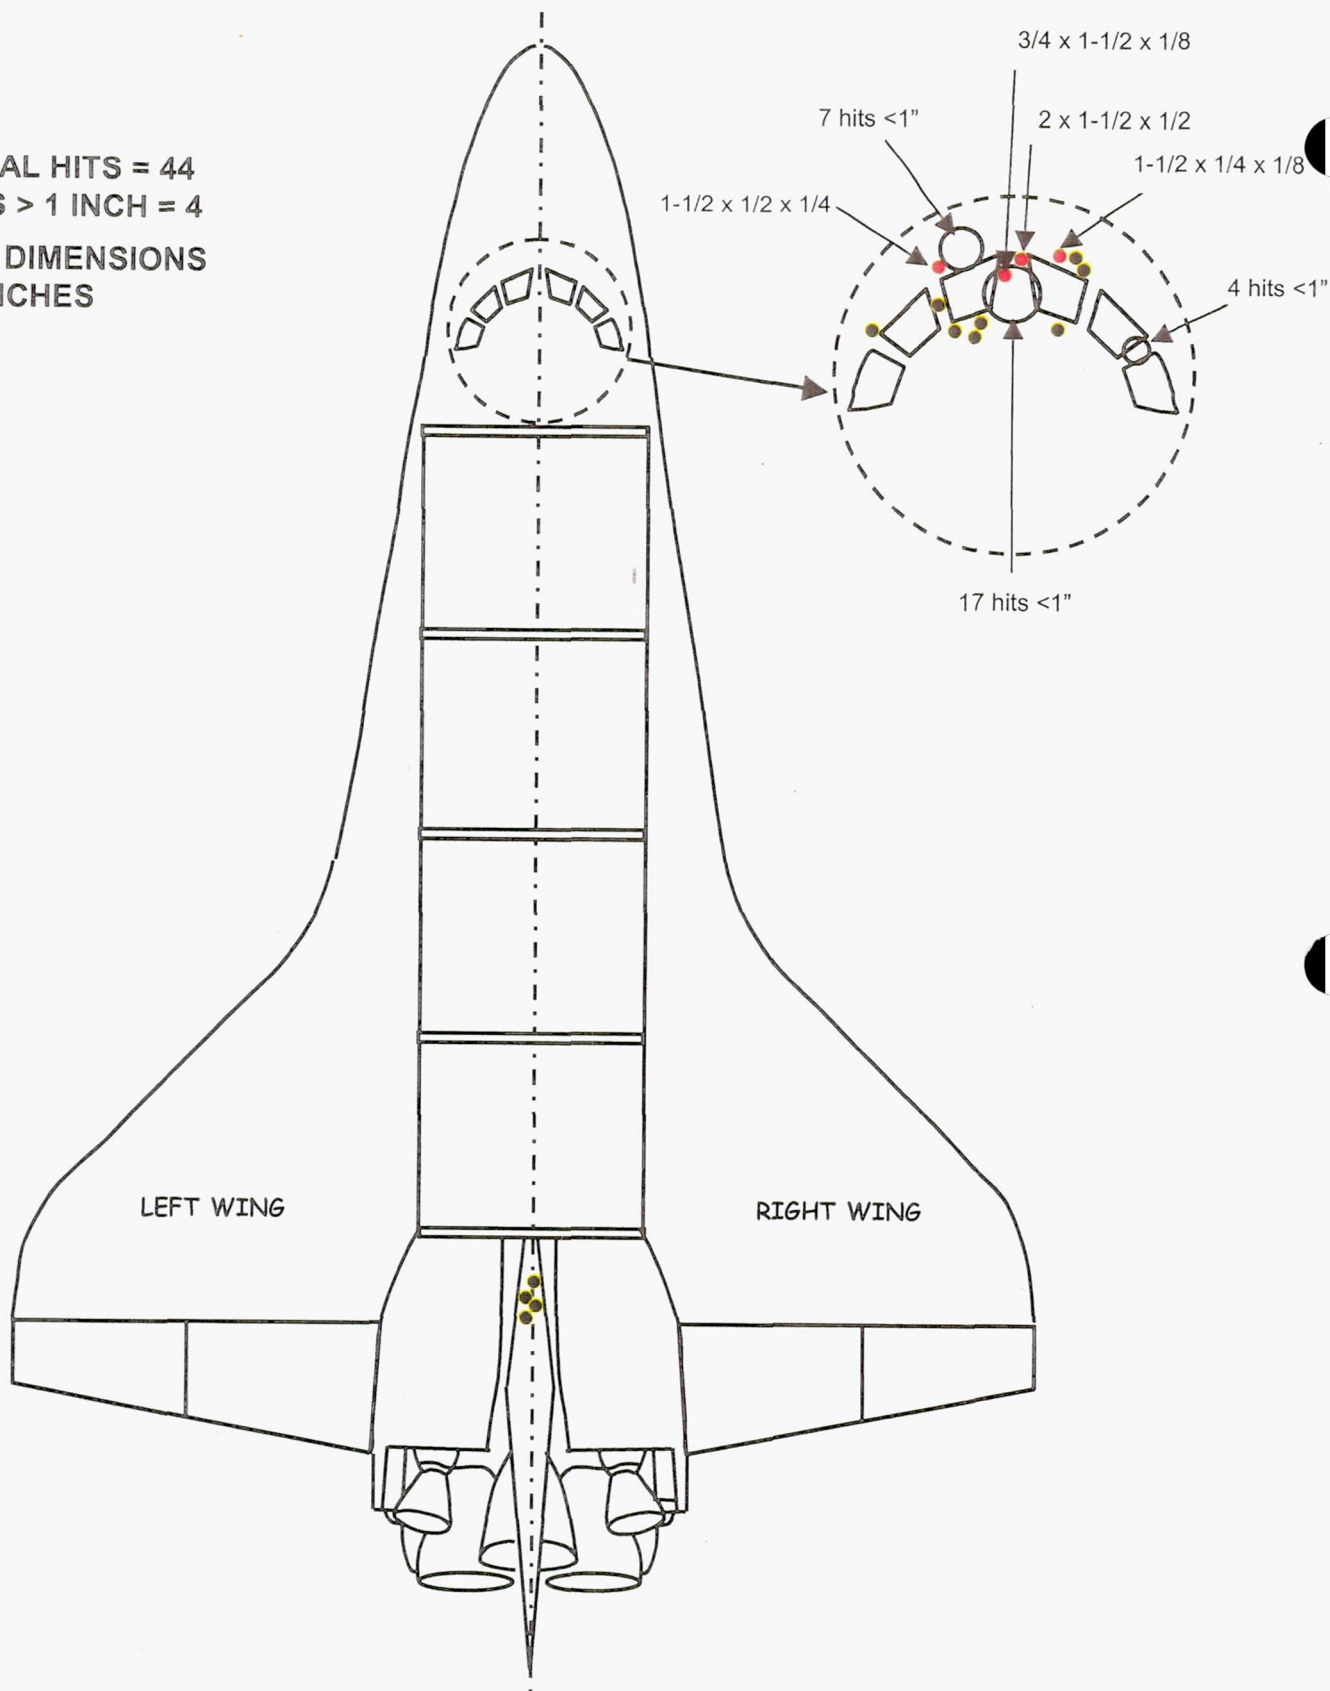
Figure 2: Orbiter Upper Surface Debris Damage Map

TOTAL HITS = 44
 HITS > 1 INCH = 4
 ALL DIMENSIONS
 IN INCHES
